**IMPACTS ON THE HUBBLE SPACE TELESCOPE WIDE FIELD AND PLANETARY CAMERA 2: EXPERIMENTAL SIMULATION OF MICROMETEOROID CAPTURE.** M. C. Price<sup>1</sup>, A. T. Kearsley<sup>2</sup>, P. J. Wozniakiewicz<sup>1,2</sup>, J. Spratt<sup>2</sup>, M. J. Burchell<sup>1</sup>, M. J. Cole<sup>1</sup>, P. Anz-Meador<sup>3,4</sup>, J.C. Liou<sup>4</sup>, D. K. Ross<sup>3,4</sup>, J. Opiela<sup>3,4</sup>, G. W. Grime<sup>5</sup>, R. P. Webb<sup>5</sup>, C. Jeaynes<sup>5</sup>, V. V. Palitsin<sup>5</sup>, J. L. Colaux<sup>5</sup>, T. Griffin<sup>6</sup> and L. Gerlach<sup>7</sup>. <sup>1</sup>School of Physical Science, University of Kent, Canterbury, CT2 7NH, UK ([mcp2@star.kent.ac.uk](mailto:mcp2@star.kent.ac.uk)) <sup>2</sup>Natural History Museum (NHM), London, UK <sup>3</sup>Jacobs Technology, Houston, TX, USA <sup>4</sup>NASA-JSC, Houston, TX, USA <sup>5</sup>Ion Beam Centre (IBC), University of Surrey, UK <sup>6</sup>NASA-GSFC, USA <sup>7</sup>consultant to ESA, ESA-ESTEC, Noordwijk, The Netherlands.

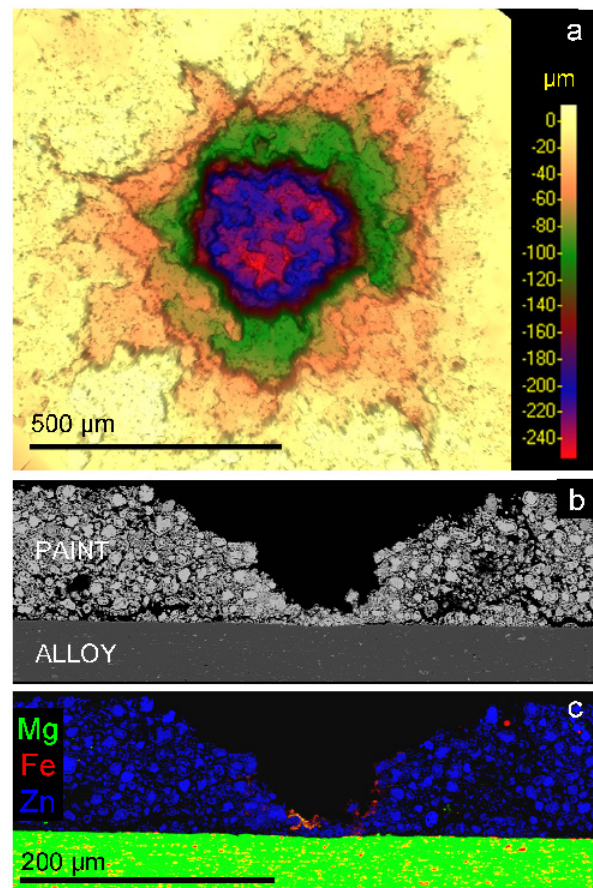
**Results:** Impacts by olivine and pyrrhotite reproduced most of the physical features seen in the smaller ( $< 600 \mu\text{m}$  diameter) WFPC2 impacts (e.g. Fig. 2).

Fig. 2. a) WFPC2-11, an impact from LEO: DEM, vertical section BEI and X-ray maps, showing Mg and Fe in MM residue lining the crater shaft and floor.

Impacts show combinations of 4 parts: 1) a downward tapering ‘cone’ from spallation of the paint surface, extending outward into radial gullies; 2) a subvertical ‘shaft’ through the lower part of the paint; 3) an exhumed surface of underlying alloy. In larger impacts a very broad shaft reveals an extensive area of metal with a fourth distinctive feature: a bowl-shaped pit or field of compound pits, excavated into alloy. Traces of impactor were found in both frothy melt (largely derived from paint), and in alloy melt on the pit surface.

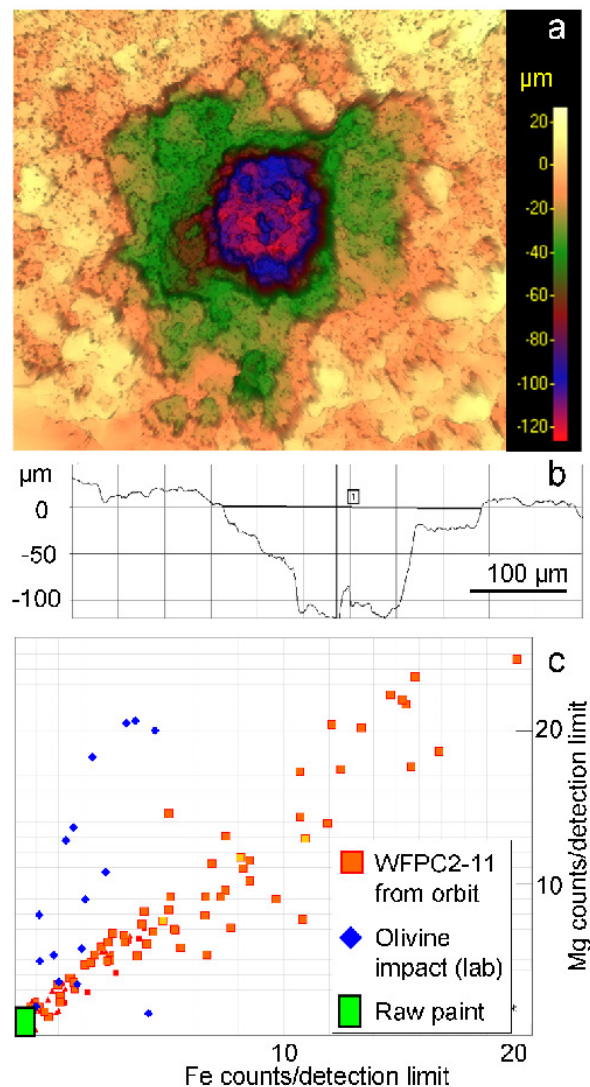
Fig. 3. Olivine LGG shot: a) DEM of impact onto WFPC2 paint; b) depth profile showing no penetration to alloy; c) plot comparison with impact in Fig 2., both showing impactor Mg and Fe added to the paint.

LGG olivine impacts are a good match for many WFPC2 features, although LEO impacts show greater diversity of Mg:Fe ratios. But does porous WFPC2 paint complicate preservation of iron sulfide remnants, by S loss due to shock heating (as in Stardust [4])?

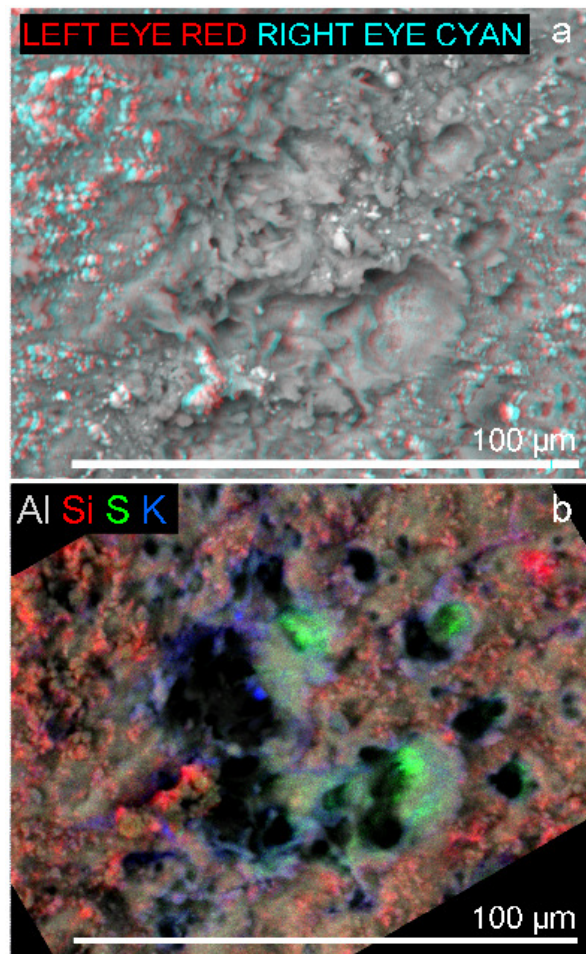
Fig. 4. Pyrrhotite LGG shot: a) Stereo BEI and b) EDX maps of compound pits in alloy surface, paint spalled.

Some sulfur is retained with iron in impact melt (Fig. 4), but impact-driven sulfur movement may also occur. More detailed study like [5] is required. Not all S-rich patches on WFPC2 are related to impact [1] as rapid growth of  $\text{KHCO}_3$  crystals on the surface of ZOT paint, aided by moist air, can scavenge atmospheric sulfur.
